**Pinnacle Infotech**

# Revit BIM helps create 3D model of acoustically designed UMBC PAHB Baltimore

## Project Summary – UMBC Performing Arts & Humanities Facility

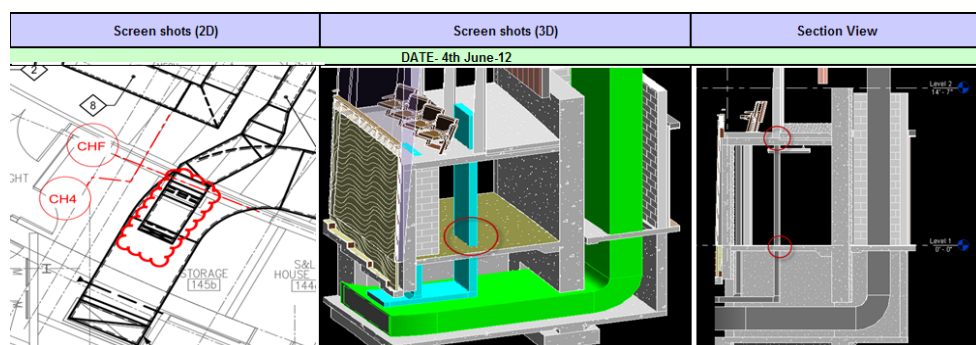
6	CH4 & CHF	Level -1	STORAGE 145b	M-2.21	Please check the up point of the of the duct as the duct riser is going through room
---	-----------	----------	--------------	--------	--

Solutions/Remarks by WHT	Pinnacle's Remarks	Final Status	Sl. No.	Grid Location	Level	Room no & Tag	Reference File	Problem Description
See attached modification of screen shot in email. I believe that the duct riser is meant to go up as a single piece of duct until it reaches the ceiling of the 1st floor and then branch out, like a "Z" shape. This may be dealt with like the previous Sfs 2.83			8	AE & 11.5	Level -1	CIRCULATION 1C05	M-2.22	Ceiling space is too small to coordinate HVAC and plumbing all together within that space.

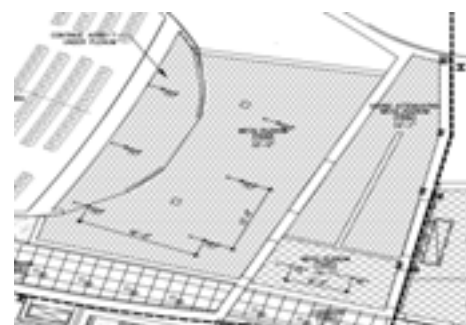
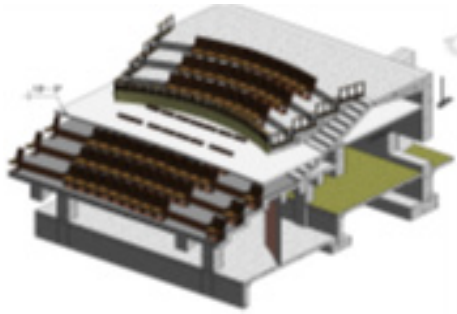
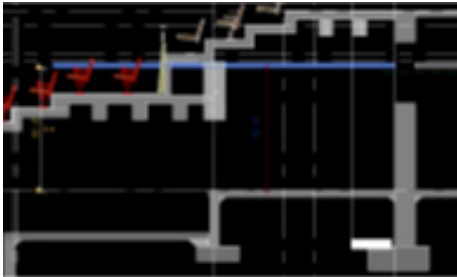
#### Architectural Trade

**Problem Description:** Pinnacle drew the ceiling layout and maintained ceiling height of mechanical plenum room as per RCP drawing A8.21. However, the ceiling clashed with the gallery, stairs, and chairs in concert hall. Moreover, the ceiling clashed with structural wall cutout. Pinnacle sent RFI to client.

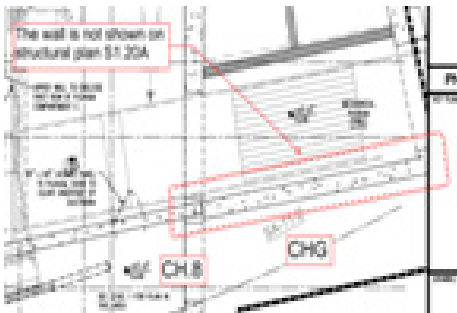
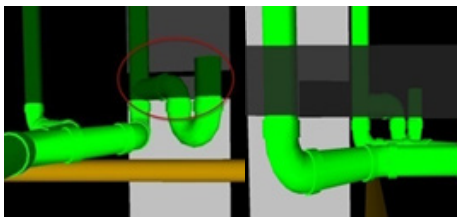
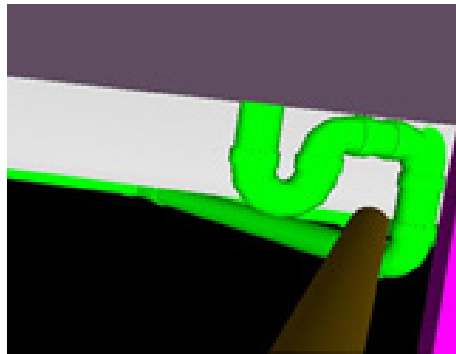
**Grid Location - CHG & CH.8, Level1, Room No. & Tag: Mech. Plenum/Corridor, Reference File: S1.20A & A5.19**

**Problem Description:** The wall was not shown on structural plan S1.20A.

PIS generated RFI #069-00 on 16th April 2012. Issue was resolved per the following screenshot. Here the elevation was adjusted from 248.30 to 247.30 as advised in RFI #69.

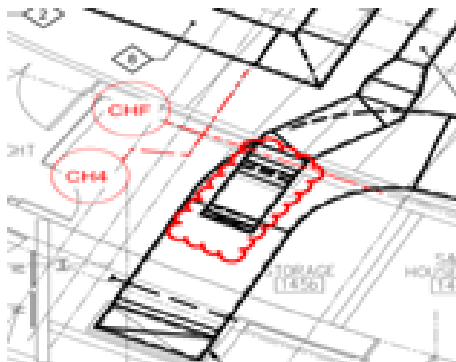
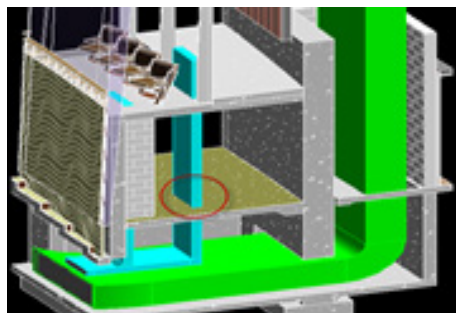
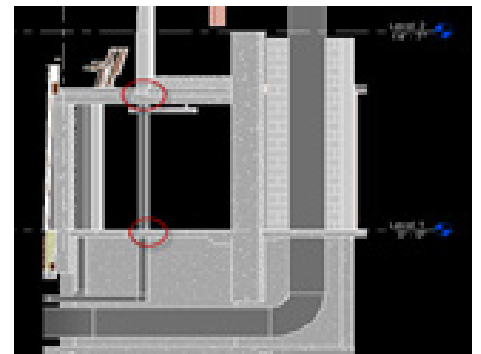
**HVAC & MP Trades - Grid Location -CH4 & CHF, Level -1 , Room No. & Tag: STORAGE 145b, Reference File: M-2.21**

**Problem Description:** The up point of the duct needs to be checked as the duct riser is going through the room.

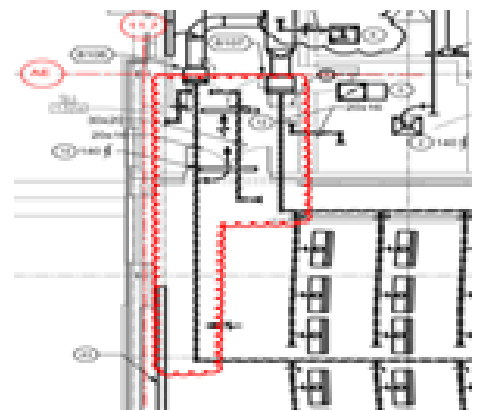
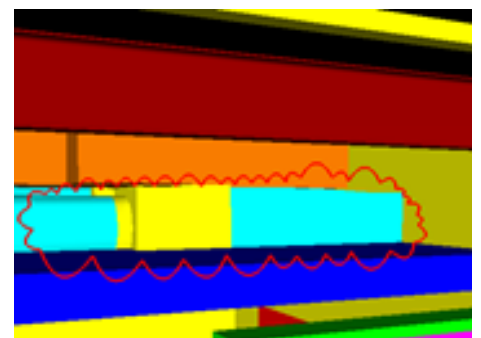
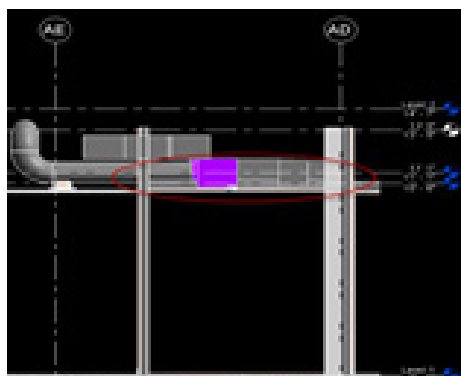
**Grid Location -AE & 11.7, Level - 1 , Room No. & Tag: CIRCULATION 1C06, Reference File: M-2.22**

**Problem Description:** Space between bottom of beam and ceiling was too small to run the duct within this area.

- The total run of the duct work was going through structural beam. BOD was maintained at 9'-6" at Level 1 Crossover room.
- Ceiling space was too small to coordinate HVAC and plumbing together within the space at Level 1 CIRCULATION 1C08.
- Space between bottom of beam and ceiling was too small to run the duct within the area at Level 1 CIRCULATION 1C06.
- Ceiling space was too small to coordinate HVAC and Concrete Beam at Level 1 LIFT 1F04.

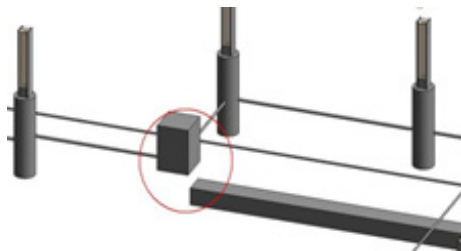
**Grid Location - AG & 9, Level -UG  
Site, Reference File: 02 E-1\_02C**

**Problem Description:** Hand hole size was 18"x18"x24". However, the duct bank elevation was given @ 36" below grade. Hence the duct bank was not fitted to hand hole.

- The size of the hand hole was 18"x18"x24" at UG Site Level. However, the duct bank elevation was given @ 36" below grade. Hence the duct bank was not fitted to hand hole.
